**A SEMI-ANNUAL AQUATIC MONITORING REPORT FOR A
SURFACE MINE PERMIT (DMLR # 1101760) LOCATED NEAR
ROARING FORK IN WISE COUNTY, VIRGINIA**

**Prepared for:
Red River Coal Company, Inc**

ATS PROJECT NO. 1199.01

October 2013

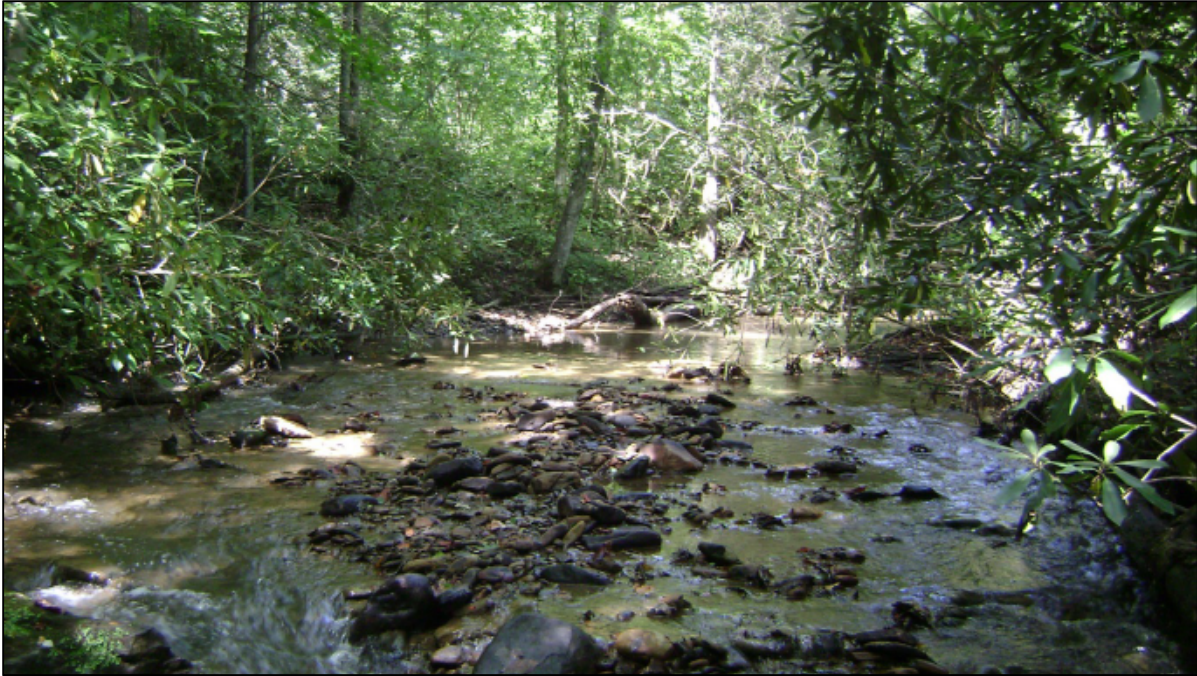
Figure 2: BRFK-1 upstream view

The stream habitat at BRFK-1 scored 139 of 200 (Appendix A), indicating the habitat is partially supporting its designated use. The stream was approximately 25 feet wide and characterized mostly by a series of riffles and runs (Figures 2 and 3). Flow occupied >75% of the stream channel. Embeddedness was suboptimal with approximately 25 to 50% of the substrate particles surrounded by fine sediment. The water was clear but there was moderate deposition of sediment within the streambed. The stream banks were moderately stable and with good riparian zones.

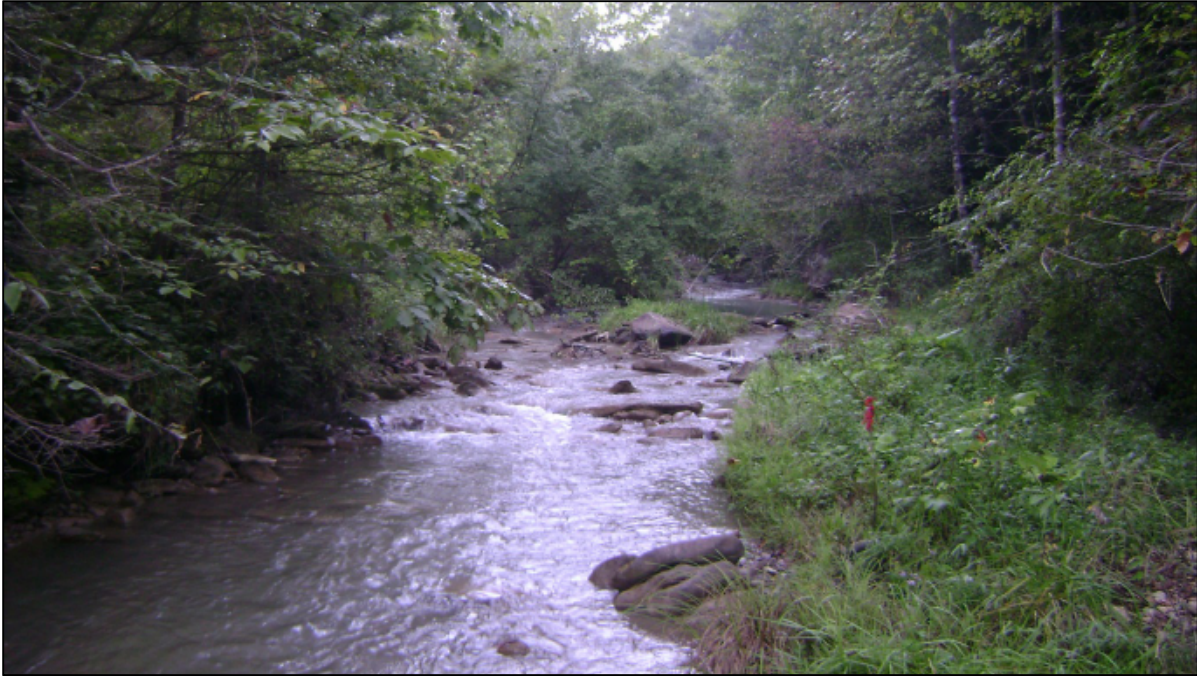
Figure 4: BRFK-2 upstream view

The stream habitat at BRFK-2 scored 130 of 200 (Appendix A), indicating the habitat is partially supporting its designated use. The stream was approximately 15 feet wide and characterized mostly by a series of riffles and runs (Figures 4 and 5). Flow occupied >75% of the stream channel. Embeddedness was suboptimal with 25 to 50% of the substrate particles surrounded by fine sediment. The water was clear but there was moderate deposition of sediment within the streambed. The stream banks were moderately stable but the right bank had a narrow riparian zone.

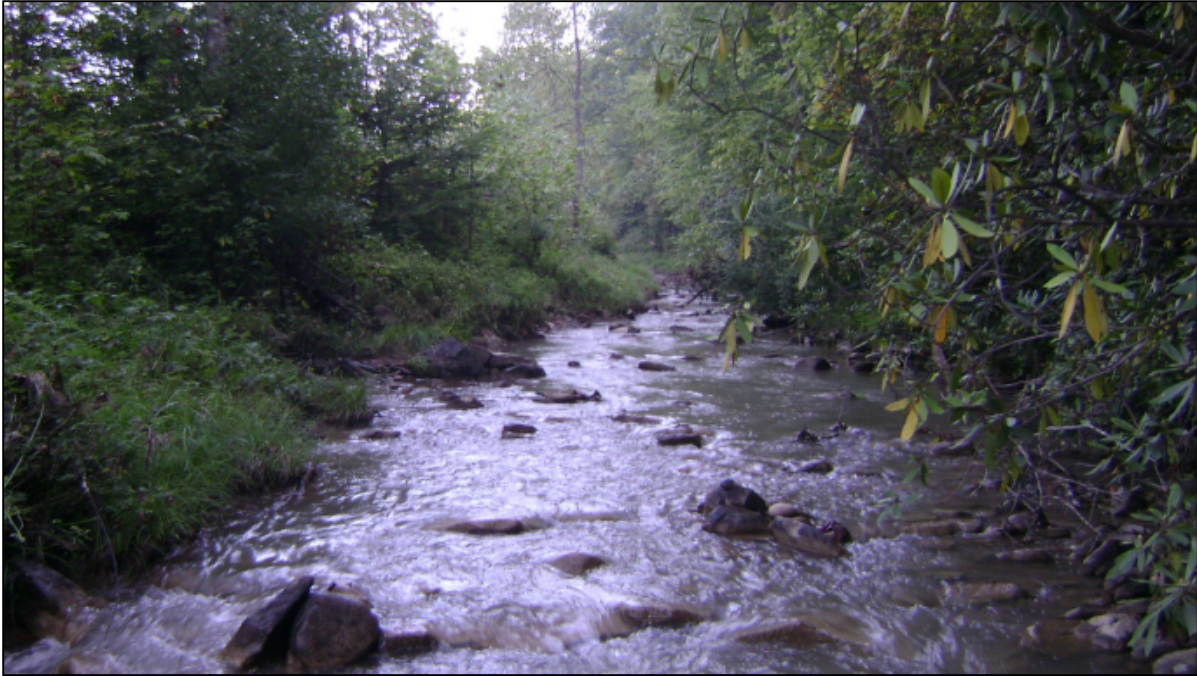
Figure 6: BRFK-3 upstream view

The stream habitat at BRFK-3 scored 130 of 200 (Appendix A), indicating the habitat is partially supporting its designated use. The stream was approximately 15 feet wide and characterized mostly by a series of riffles and runs (Figures 6 and 7). Flow occupied >75% of the stream channel. Embeddedness was suboptimal with 25 to 50% of the substrate particles surrounded by fine sediment. The coloration of the water was clear and there was evidence of slight siltation within the streambed. The stream banks were moderately stable but the right bank had a narrow riparian zone.

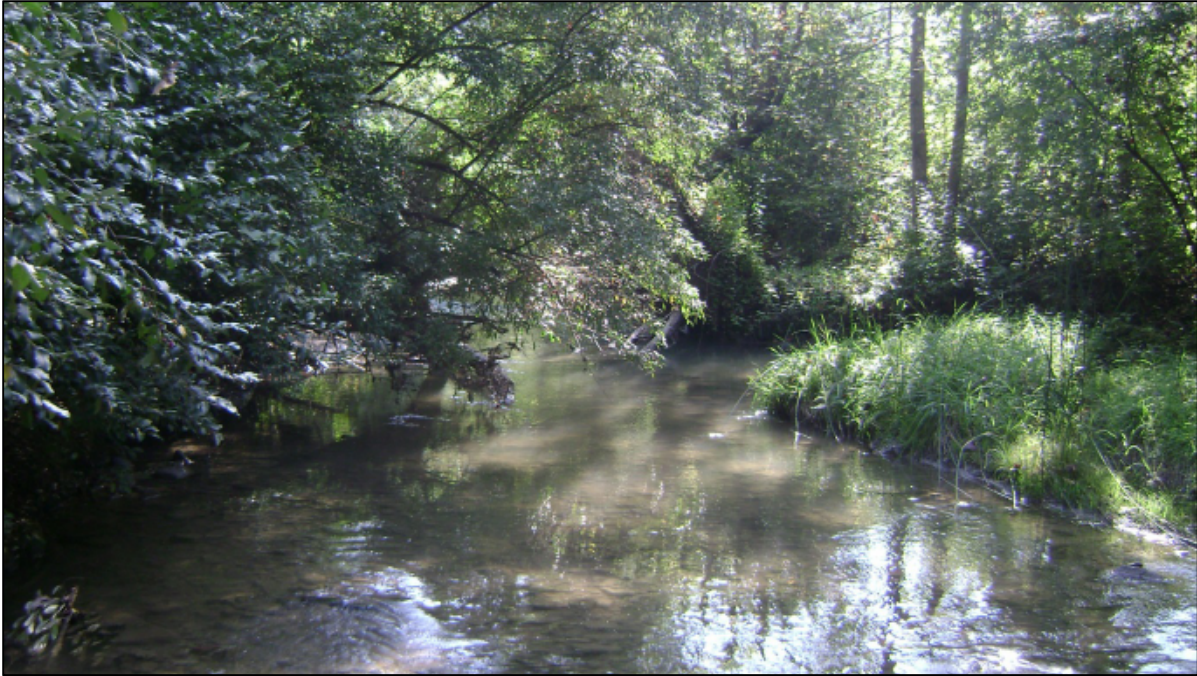
Figure 8: BRFK-4 upstream view

The stream habitat at BRFK-4 scored 144 of 200 (Appendix A), indicating the habitat is partially supporting its designated use. The stream was approximately 25 feet wide and characterized mostly by a series of riffles and runs (Figures 8 and 9). Flow occupied >75% of the stream channel. Embeddedness was suboptimal with approximately 25 to 50% of the substrate particles surrounded by fine sediment. The coloration of the water was clear but there was evidence of moderate sedimentation within the streambed. Both stream banks had suboptimal vegetation and good riparian zones.

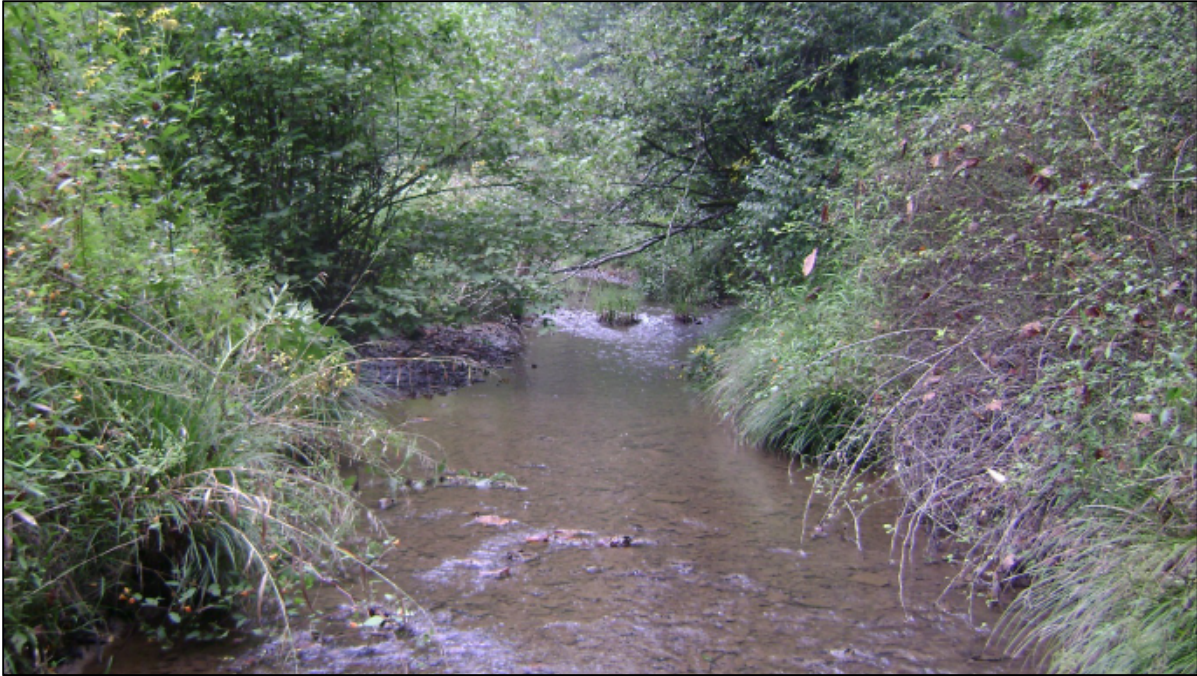
Figure 10: BCPT-1 upstream view

The stream habitat at BCPT-1 scored 128 of 200 (Appendix A), indicating the habitat is partially supporting its designated use. The stream was approximately 15 feet wide and characterized mostly by a series of riffles and runs (Figures 10 and 11). Flow occupied >75% of the stream channel. Embeddedness was suboptimal with 25 to 50% of the substrate particles surrounded by fine sediment. The coloration of the water was clear but there was evidence of moderate sedimentation within the streambed. The stream banks were moderately unstable and with good riparian zones.

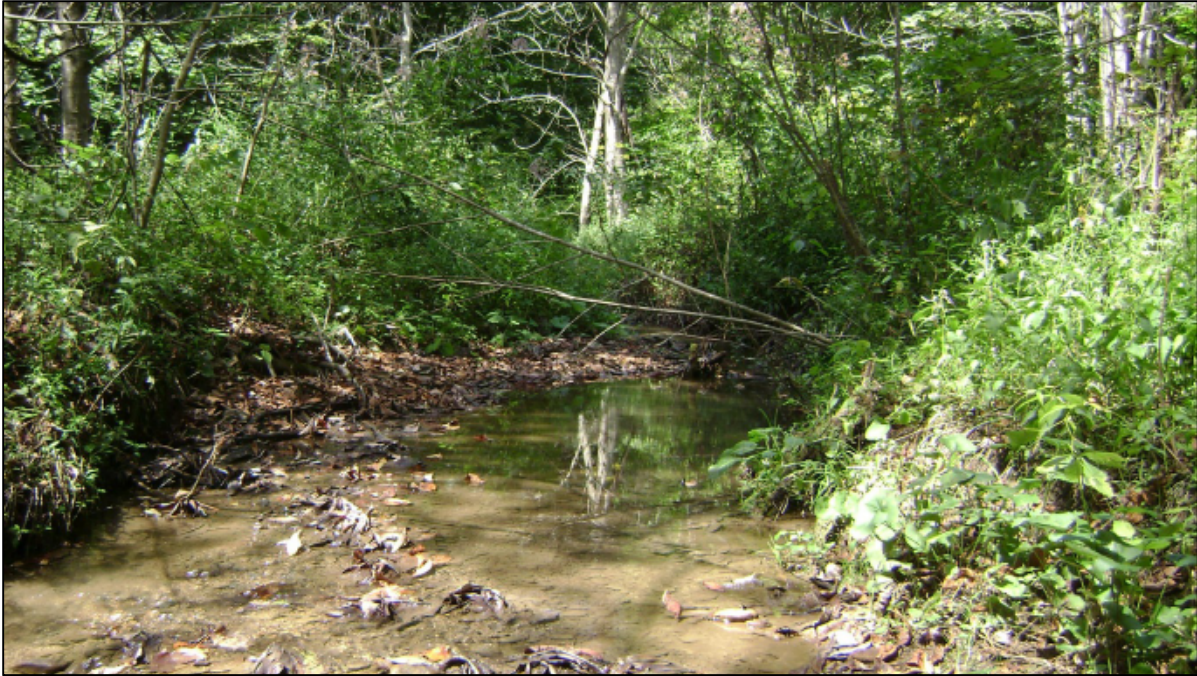
Figure 12: BPR-1 upstream view

The stream habitat at BPR-1 scored 139 of 200 (Appendix A), indicating the habitat is partially supporting its designated use. The stream was approximately 4 feet wide and characterized mostly by a series of runs and riffles (Figures 12 and 13). Flow occupied >75% of the stream channel. Embeddedness was suboptimal with approximately 25 to 50% of the substrate particles surrounded by fine sediment. The coloration of the water was clear but there was evidence of moderate deposition of sediment within the streambed. The stream banks were unstable but with good riparian areas.
